AFRL-ML-WP-TR-2001-4020

**LIFE PREDICTION METHODOLOGIES FOR
AEROSPACE MATERIALS**

**UNIVERSITY OF DAYTON RESEARCH INSTITUTE
STRUCTURAL INTEGRITY DIVISION
300 COLLEGE PARK
DAYTON, OHIO 45469-0128**

INTERIM REPORT FOR PERIOD 25 MAY 1999 - 24 MAY 2000

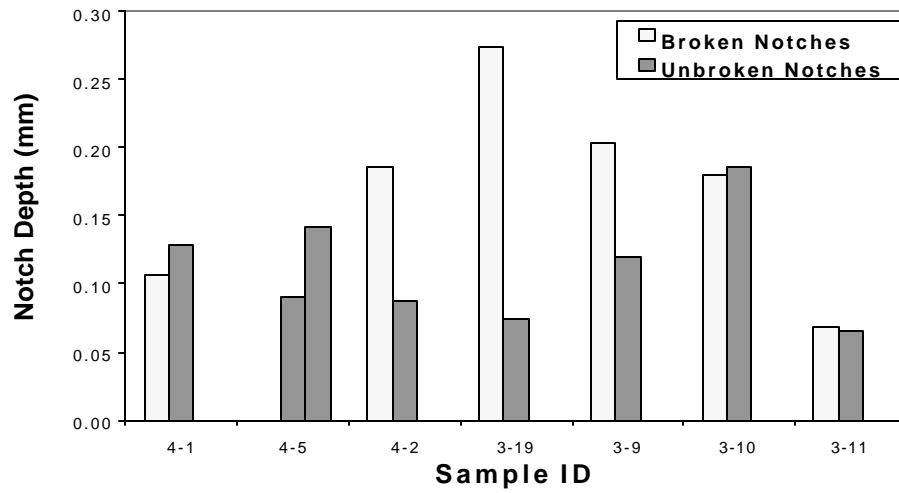
Figure 4: Depth of Broken Notches vs. Depth of Unbroken Notches for 0° impacts

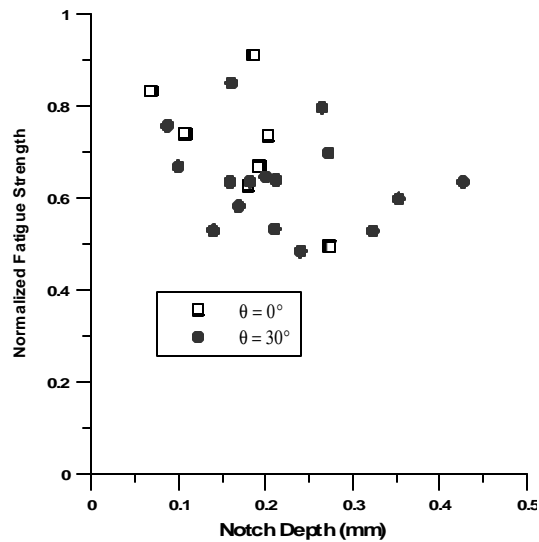
Figure 5: Comparison of notch depth and the fatigue strength

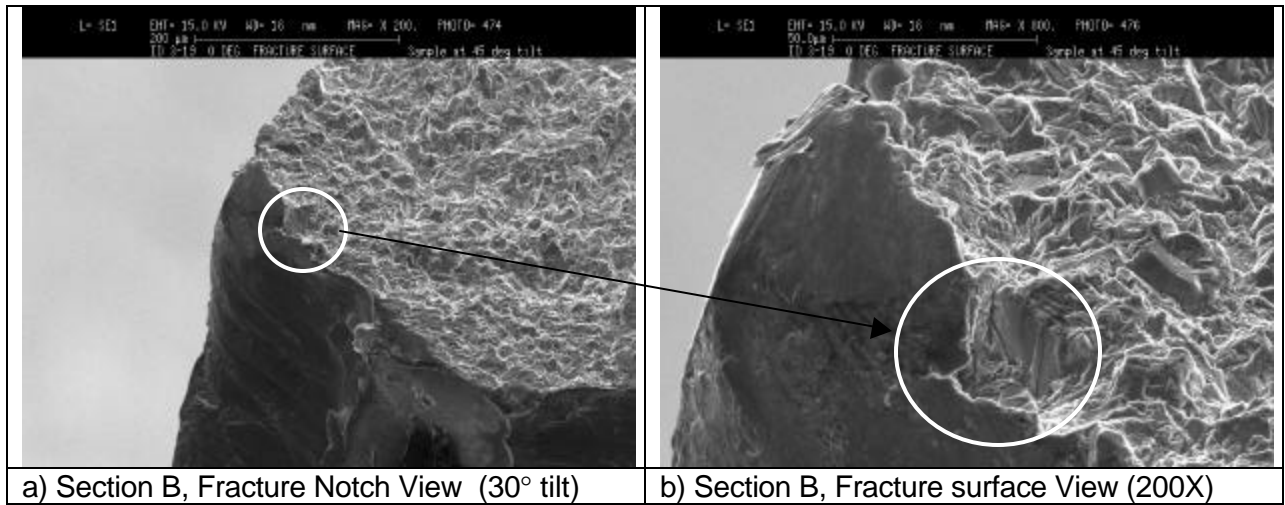
Figure 9: Fracture initiation of Sample 3-19

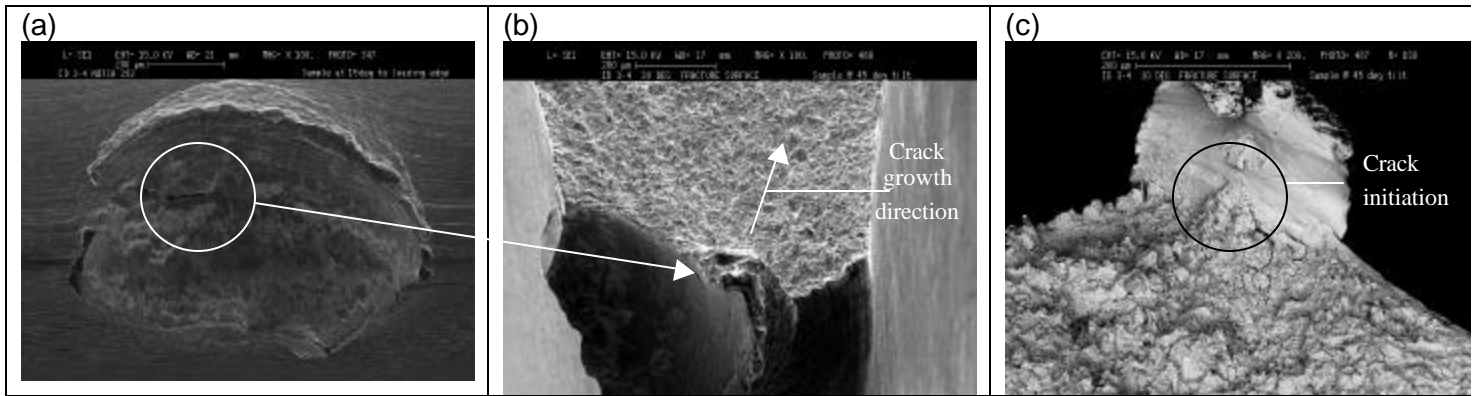
Figure 11: Shearing: a) Before fracture picture of sample 3-4, material shear parallel to LE b) After fracture photo; c) After fracture photo behind material shear

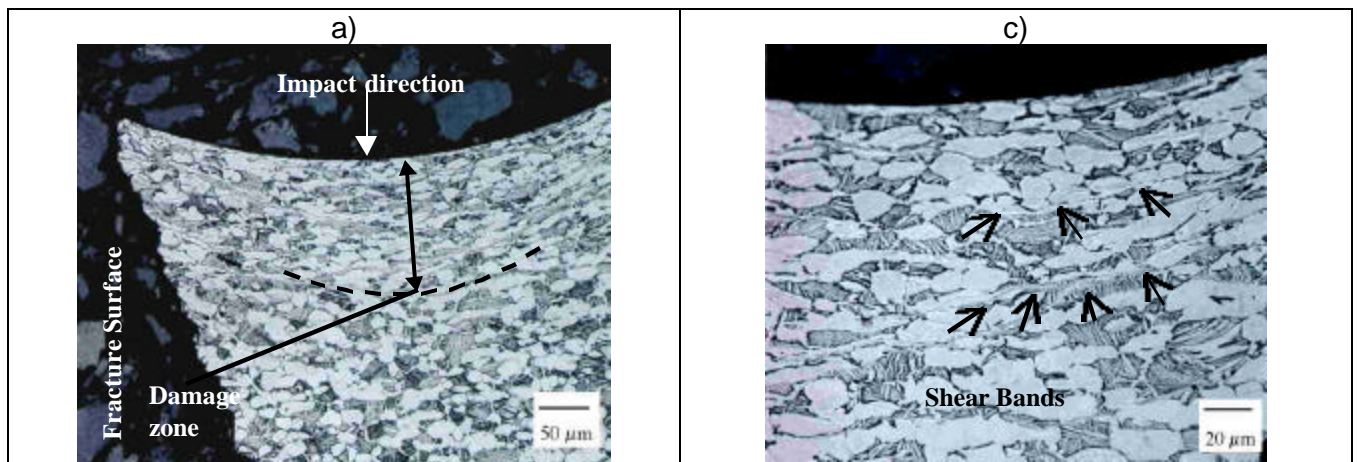
Figure 14: Precision Micro-sectioning of sample 3-13
